SUBJ: Resource Conservation and Recovery Act (RCRA) Compliance Evaluation Inspection (CEI)
Valmont Coatings Inc. dba Valmont Birmingham Galvanizing
EPA ID # ALR000013490

RCRA Inspection Report

VALMONT COATINGS INC. DBA VALMONT BIRMINGHAM GALVANIZING

COMPLIANCE EVALUATION INSPECTION PHOTOGRAPHS

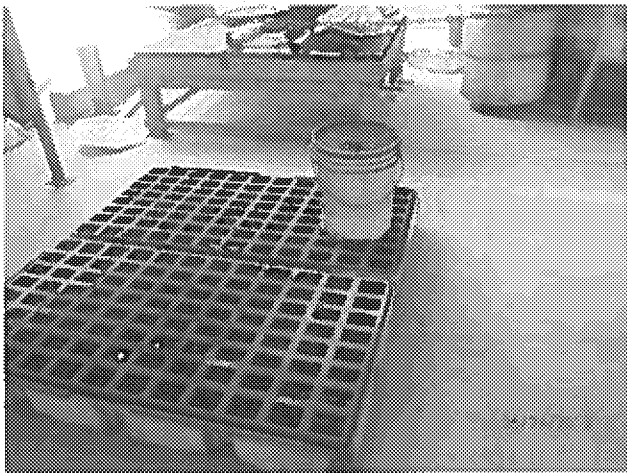
The CAA was located near the loading dock doors. The area was chained off and contained empty drums stacked on their sides and a white 5-gallon container of used oil sitting on a secondary containment pallet. The used oil container was observed not closed and not labeled. In addition, the secondary containment pallet contained oil and was not closed and not labeled. The inspectors advised Mr. Cunningham and Mr. McDonough to clean out the secondary containment pallet or label and close it per used oil regulations. No hazardous waste was observed in the area at the time.

Picture 1 – CAA used oil container

1. *Used oil not labeled*
2. *Same used oil not closed*
 - a. *1. and 2. Bucket was emptied into 55-gallon drum of waste diesel fuel and water*
3. *Spill control pallet has oil in the bottom of it*

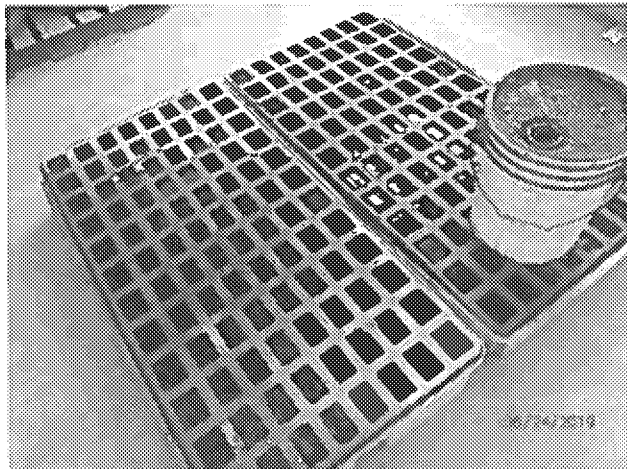
Picture 2 – CAA used oil secondary containment

- a. *Oil was poured into 55-gallon drum and labeled. Spill pallet was cleaned*
4. *Satellite accumulation container (55-gallon drum) and plastic container of MEK not closed*

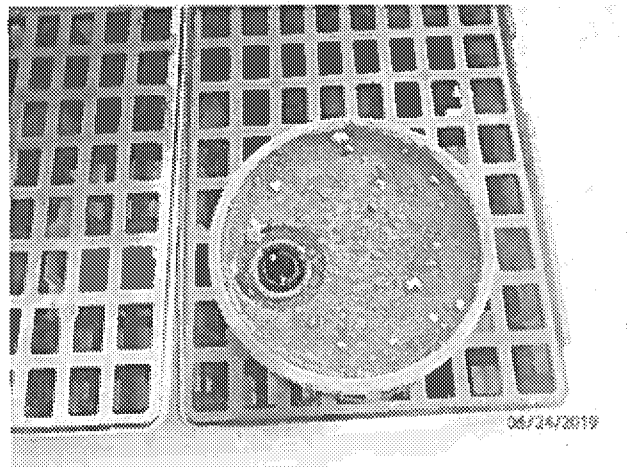
Pursuant to ADEM Admin. Code r. 335-14-17-.03 (4)(a)1., a container holding used oil must always be closed during storage, except when it is necessary to add or remove used oil.

Picture 3 – CAA used oil container open

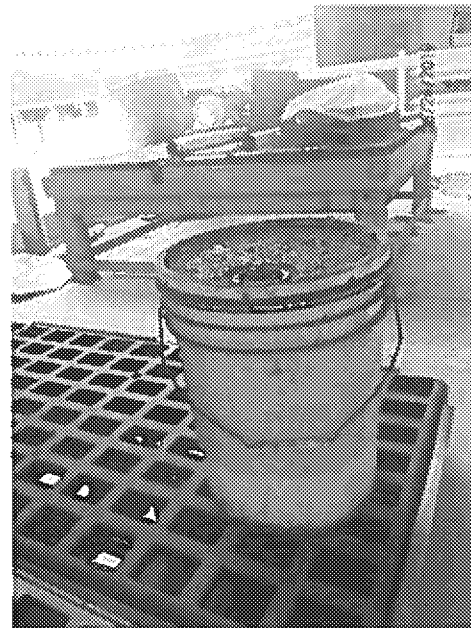
Pursuant to ADEM Admin. Code r. 335-14-17-.03 (4)(c)1., [40 C.F.R. § 279.22(c)(1)], containers and aboveground tanks used to store used oil at generator facilities must be labeled or marked clearly with the words "Used Oil."

Picture 4 – CAA used oil container

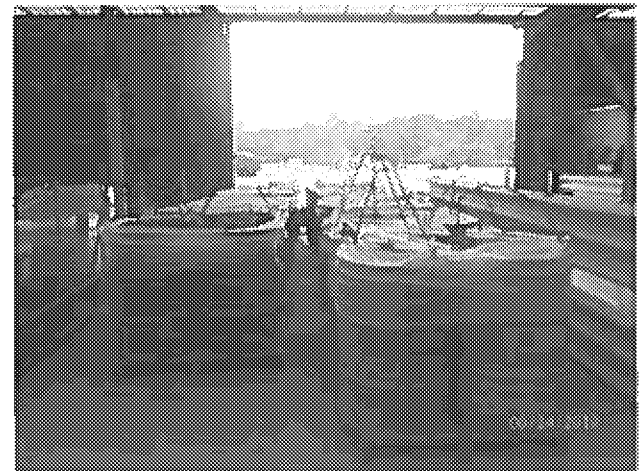
Beside the CAA were forty-four 55-gallon drums of burnt zinc from the Metaullics Zinc Recovery (MZR) System (Picture 5). The drums of burnt zinc are to be sold for reclamation of the zinc content.

Picture 5 – Burnt Zinc drums to be sold

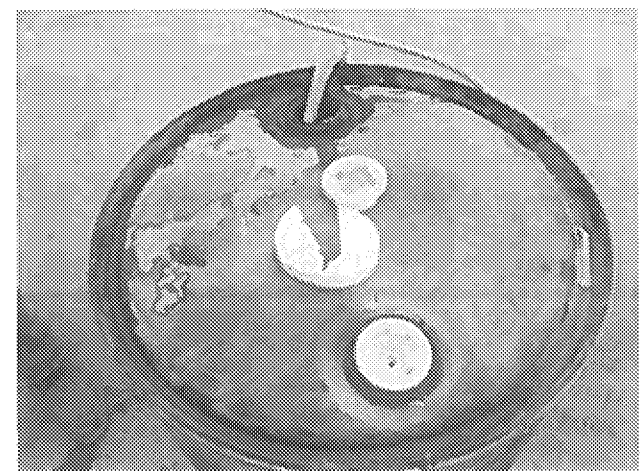
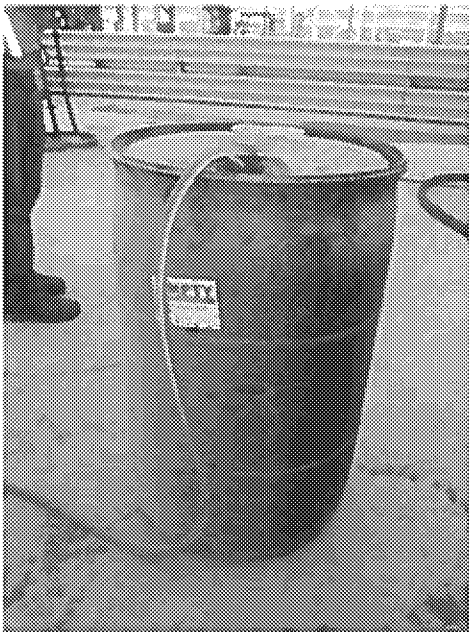
The inspectors observed a black 55-gallon drum with a green hose in the bung (Pictures 6-7). Mr. Cunningham and Mr. McDonough explained that the diesel fuel tank was moved indoors because of the constant intake of rain into the tank. The water and diesel sludge were released into the sump, and then pumped into the drum. Mr. Cunningham said the contents of the drum would be analyzed.

Pursuant to ADEM Admin. Code r. 335-14-3-.01(5)(a)5 [40 C.F.R. § 262.15(a)(5)], which is a condition of the SAA Permit Exemption, a generator is required to mark or label its containers (i) with the words "Hazardous Waste" and (ii) with an indication of the hazards of the contents.

Picture 6 – Sump HW diesel and water drum

Picture 7 -- Sump HW diesel and water drum

The inspectors explained that the satellite accumulation area (SAA) drum must be labeled "hazardous waste" and "pending analysis" and dated until the results are received.

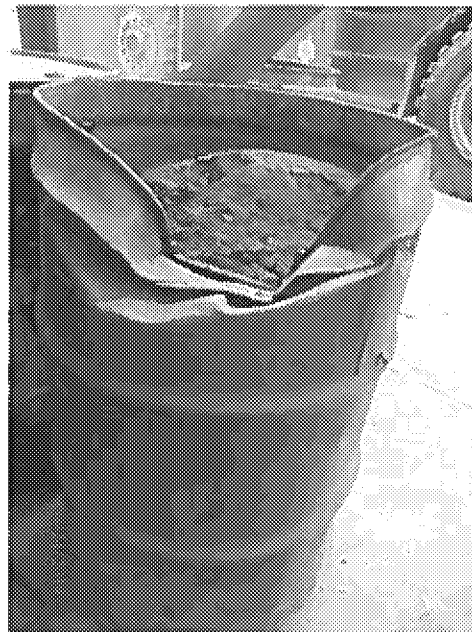
The galvanizing process is located between the two product areas. The inspectors observed thirteen 55-gallon drums of zinc dross (Picture 9) and one 55-gallon drum of burnt zinc (Picture 10) to be sold for reuse.

Picture 10 -- Burnt Zinc drum to be sold

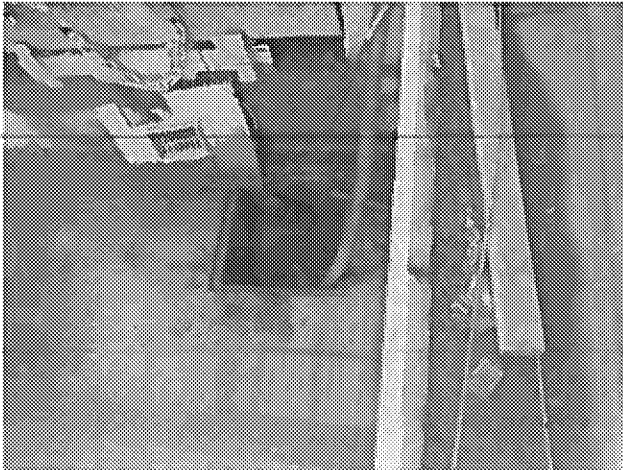
Picture 8 -- Sump full of diesel and water

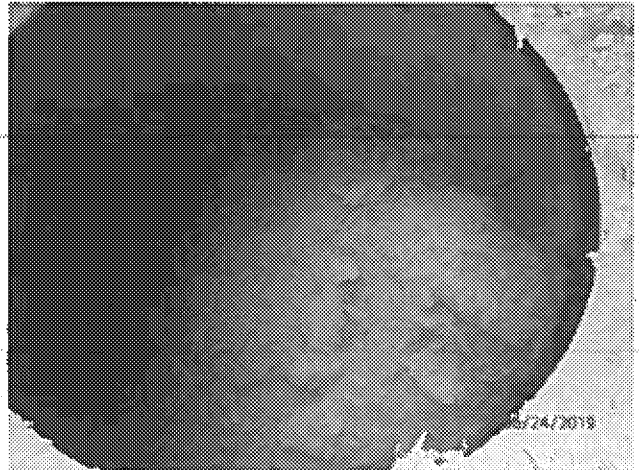
The zinc skims are removed from the zinc kettle manually using a basket (Picture 11). The scooped-out skims are placed into a container for the MZR (Picture 13). The MZR system separates the zinc dross using high temperature and a rotating drum to separate out the impurities in the dross. Once the zinc is molten it is poured into a mold to solidify (Picture 12).

Picture 11 -- Zinc skimmings from Kettle

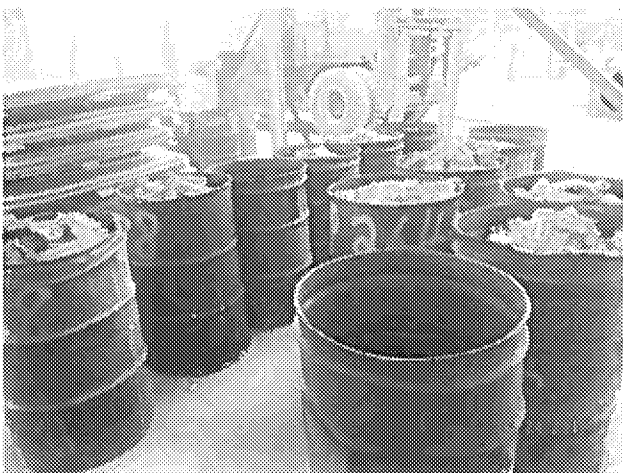
Picture 9 -- Zinc Dross drums to be sold

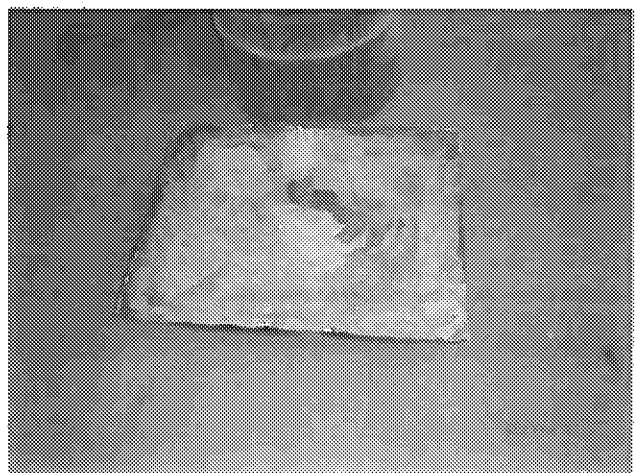
Picture 12 -- MZR zinc ingot

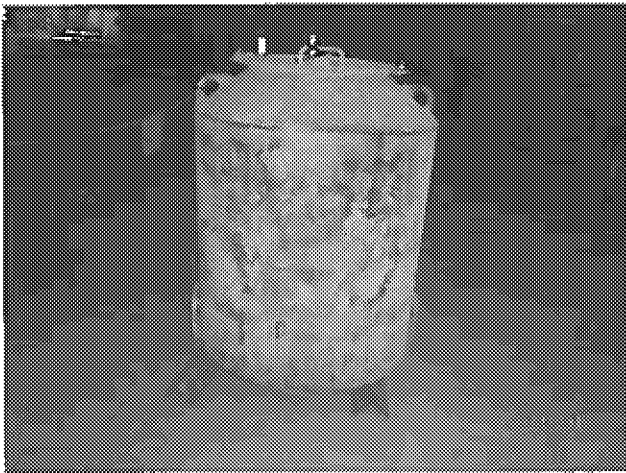
Picture 13 -- MZR barrel

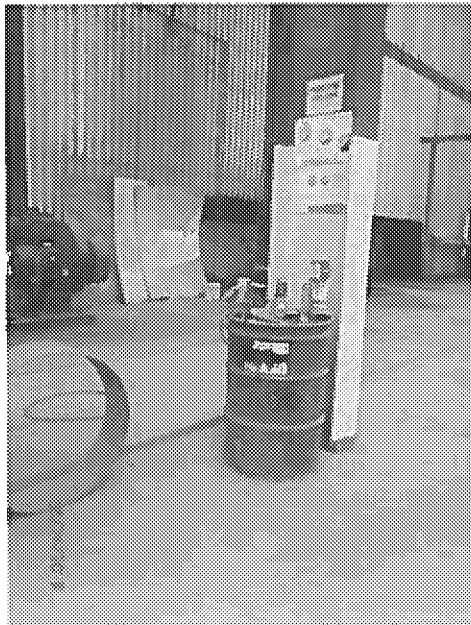
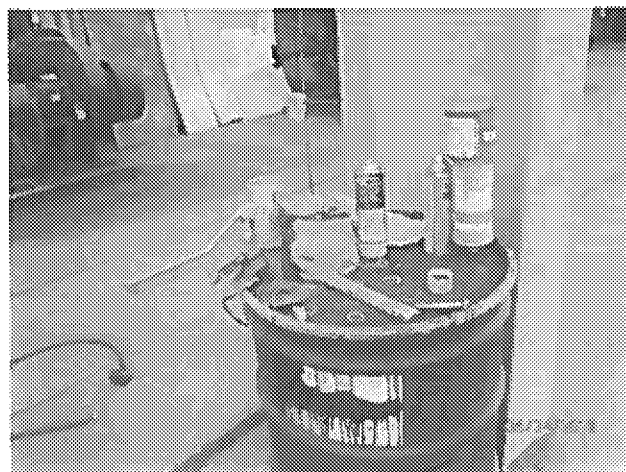
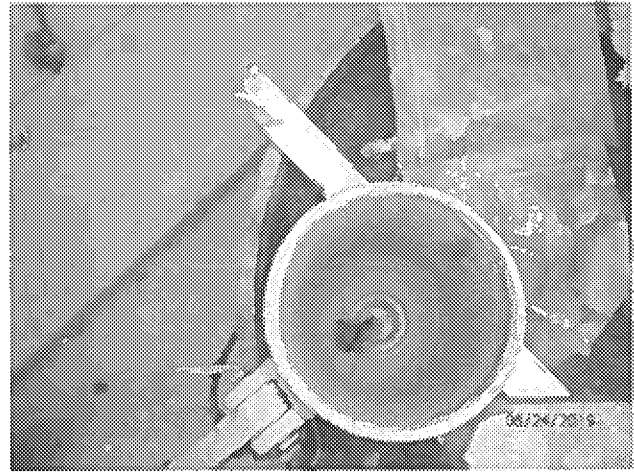
The inspectors observed a spent aerosol can puncture system on a 55-gallon drum. The drum was not labeled, and the puncture system attached to the bung hole was not closed (Pictures 14-16). Mr. Cunningham explained that the zinc paint residue collected is not disposed of but reused to touch up the poles and that the residue is not a waste.

Picture 16 -- Puncture can system open

Picture 14 -- Puncture can station

Picture 15 -- Puncture can system and residue drum

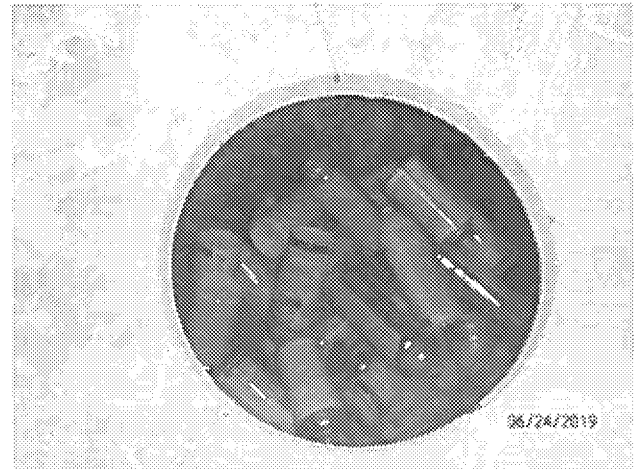
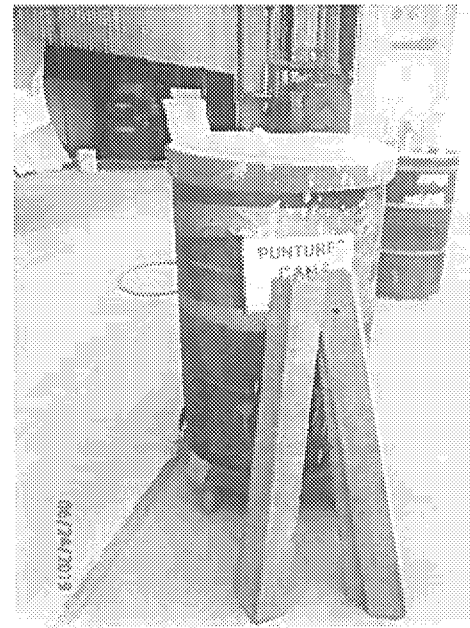
Near to the spent aerosol can drum was a 55-gallon drum used to collect scrap cans that had been punctured (Pictures 17-18). A 55-gallon drum labeled "Spray Cans" contained punctured cans and trash instead of unpunctured spent aerosol cans (Pictures 19-20). The inspectors also observed a 55-gallon drum of one-gallon zinc paint cans with dried residue (Picture 21).

Picture 17 -- Punctured cans drum

Picture 18 -- Punctured cans drum

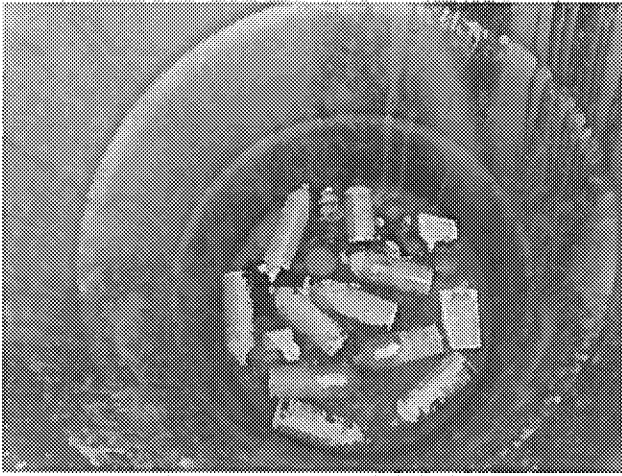
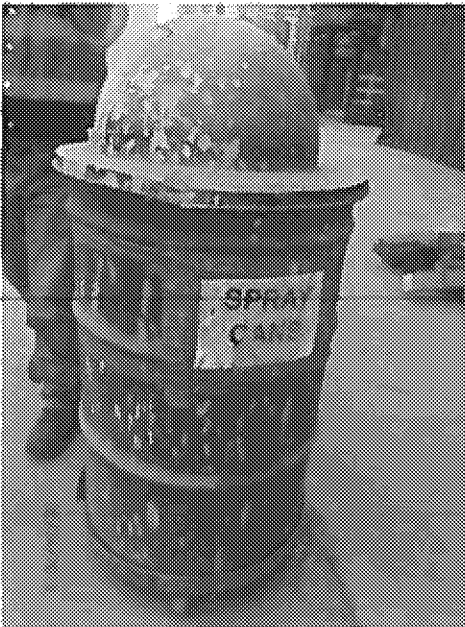
Picture 19 -- Spray Cans drum for unpunctured cans

Picture 20 -- Spray Cans drum for unpunctured cans

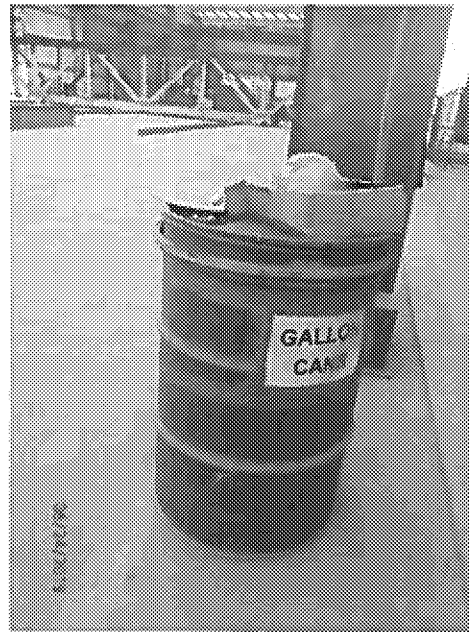
Picture 21 -- Gallon paint cans drum

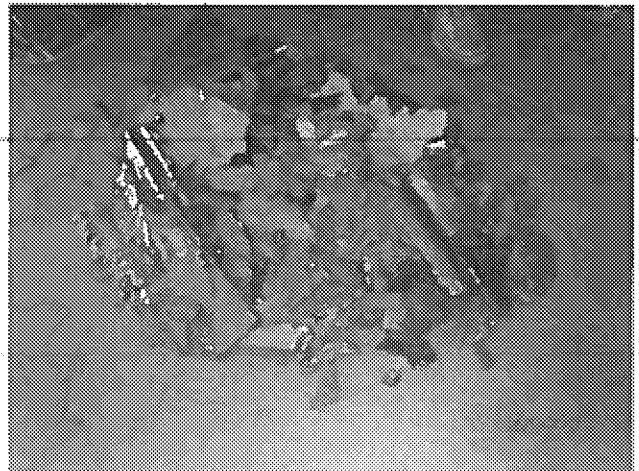
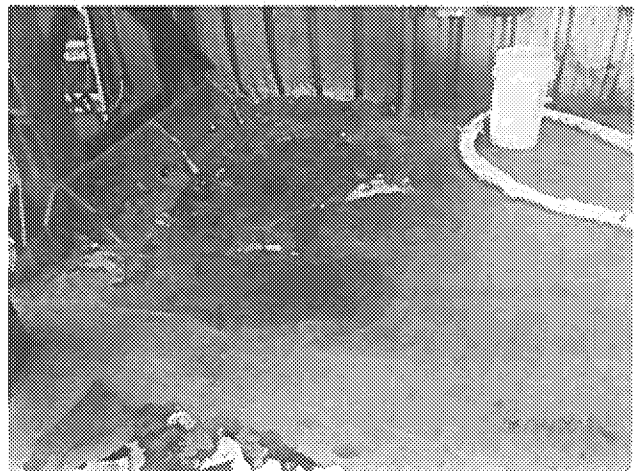
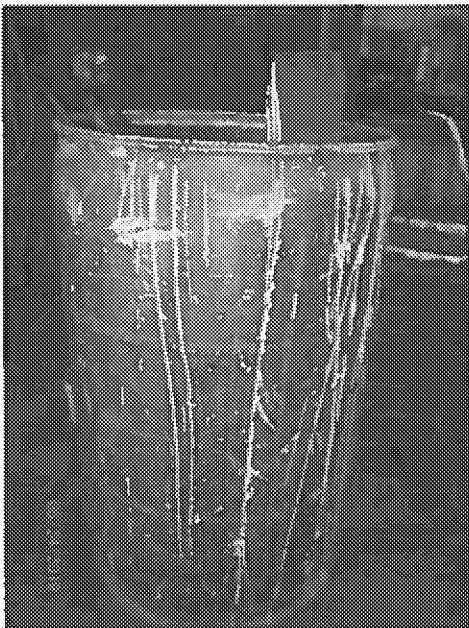
Depending on the customers, polyvinyl two-part epoxy paint is used. The inspectors observed in the Polyvinyl Area dried overspray residue on the floor, scraped up in a pile and then placed in a 55-gallon drum (Pictures 22-24). Also, four 55-gallons of reclaimed blast media shot was stored in this area (Picture 25). The shot will be put back into the process and reused.

Picture 22 -- Polyvinyl overspray to be discarded

Picture 23 -- Polyvinyl overspray to be discarded

Picture 24 -- Polyvinyl overspray discarded

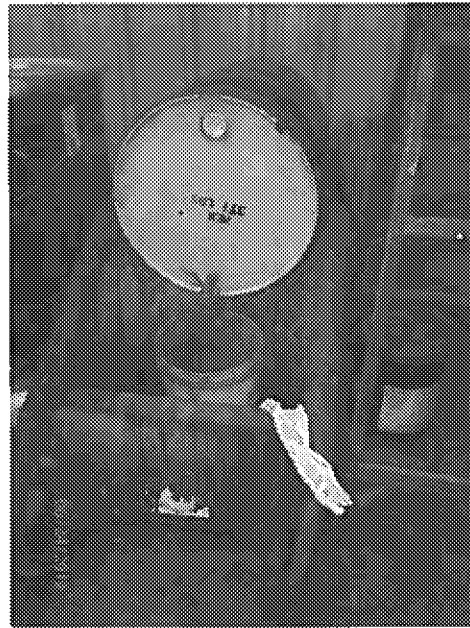
The inspectors observed a 55-gallon drum of methyl ethyl ketone (MEK) with a faucet attached to the bung (Picture 26). The secondary containment under the drum was filled with MEK and a container filled with MEK and two brushes (Picture 27). The MEK is used to clean the paint brushes and the paint gun. Small containers of MEK used for cleaning was observed on the worktop (Picture 28).

Picture 26 -- Paint Room MEK drum

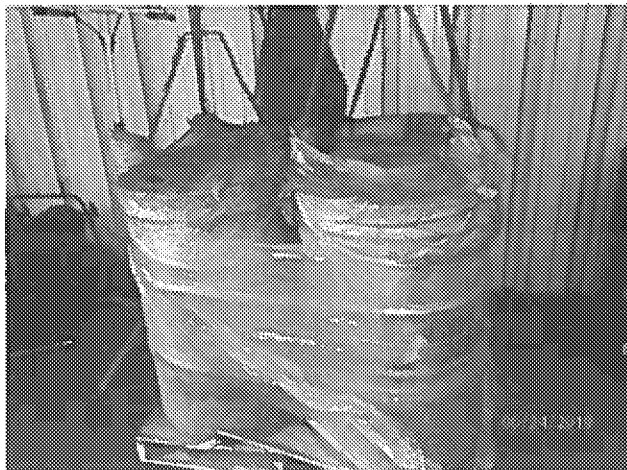
Picture 25 -- Reclaimed shot blast to be reused

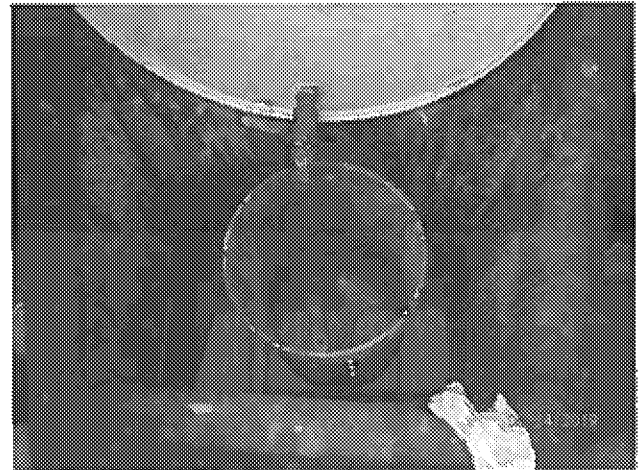
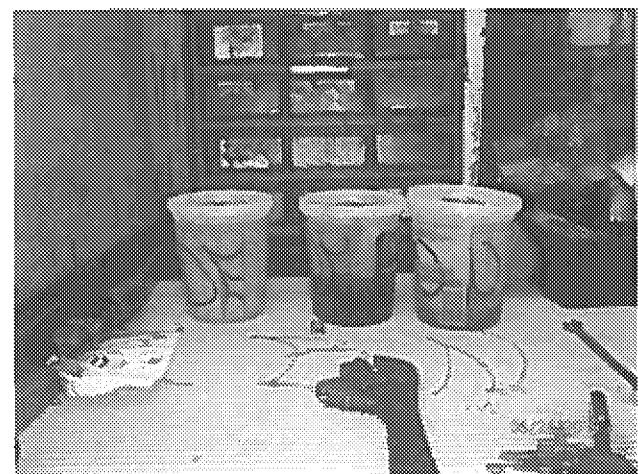
Picture 27 -- Paint Room MEK brush cleaner

Picture 28 -- Paint Room MEK brush cleaner

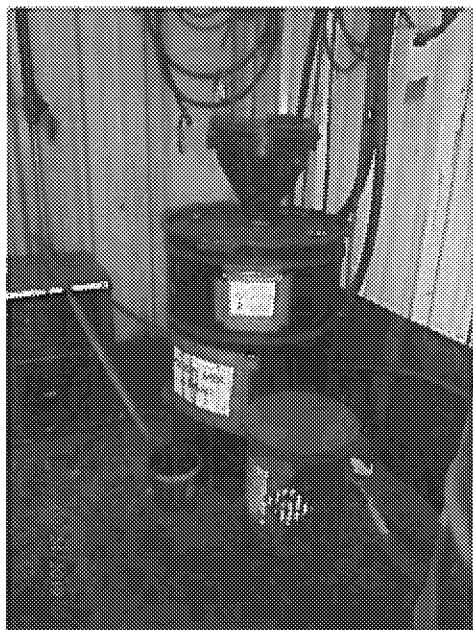
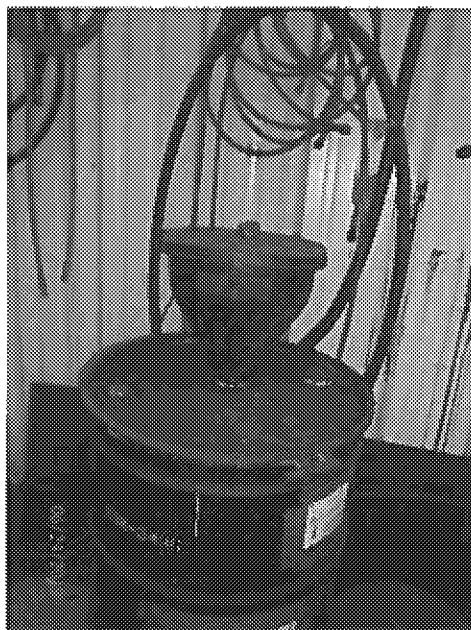
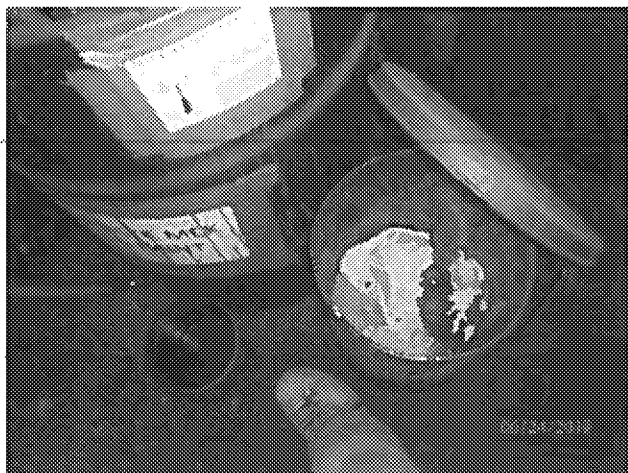
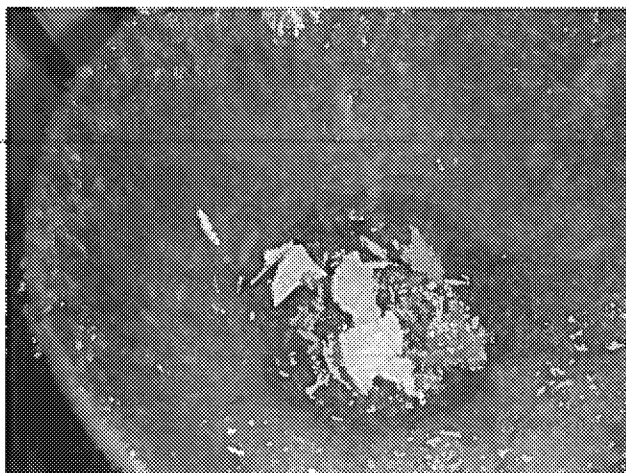
The inspectors also observed a 55-gallon SAA drum of waste MEK and paint with a red funnel that was not closed, a red SAA step can of waste MEK contaminated rags and personal protective equipment and a half gallon container of waste MEK and paint that was not closed or labeled (Pictures 29-32).

Pursuant to ADEM Admin. Code r. 335-14-3-.01(5)(a)4 [40 C.F.R. § 262.15(a)(4)], which is a condition of the SAA Permit Exemption, a generator is required to keep containers of hazardous waste closed at all times during accumulation, except when adding, removing, or consolidating waste; or when temporary venting of a container is necessary for the proper operation of equipment, or to prevent dangerous situations, such as build-up of extreme pressure.

Pursuant to ADEM Admin. Code r. 335-14-3-.01(5)(a)5 [40 C.F.R. § 262.15(a)(5)], which is a condition of the SAA Permit Exemption, a generator is required to mark or label its containers (i) with the words "Hazardous Waste" and (ii) with an indication of the hazards of the contents.

Picture 29 -- Paint Room HW MEK containers

Picture 31 -- Paint Room HW MEK drum

Picture 30 -- Paint Room HW MEK rags/PPE

Picture 32 -- Paint Room HW MEK drum funnel

- a. *Latch repaired and locked*
5. *One satellite container (55-gallon drum) and plastic container not labeled properly*
 - a. *Accumulation drums closed and labeled. Plastic container with MEK was put in the accumulation drum. Container was labeled.*
